1.5.x Customer Release Notes

Chapter 1—Selenia Dimensions 1.5.2 Release Notes Introduction

Chapter 1 Selenia Dimensions 1.5.2 Release Notes

Chapter 2 Selenia Dimensions 1.5.1 Release Notes

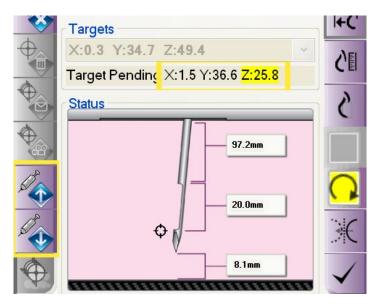
The following targeting enhancements were added to this software release:

When the user jogs the needle up or down to the extent that the selected target falls
outside the aperture of the biopsy device, the *Z-value* of the "*Targets Pending*" is
displayed in yellow as a warning that the removed tissue may not include the
targeted area.
